**ST. ALBANS RESERVOIR DAM (NORTH)  
VT 00058**

**PHASE I INSPECTION REPORT  
NATIONAL DAM INSPECTION PROGRAM**

**DEPARTMENT OF THE ARMY  
NEW ENGLAND DIVISION, CORPS OF ENGINEERS  
WALTHAM, MASS. 02154**

SEPTEMBER 1978

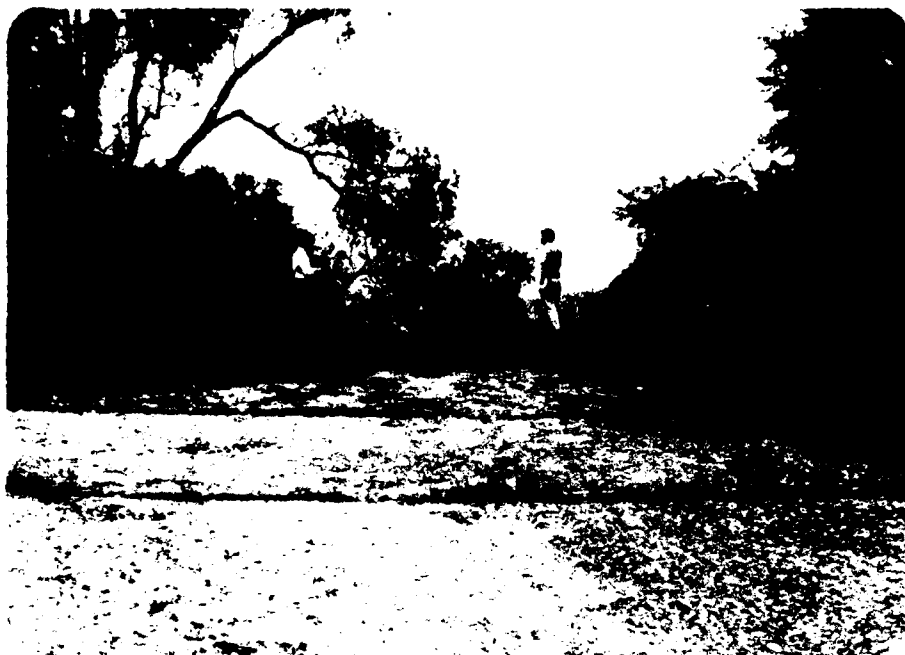
The concrete retaining walls on either side of the spillway are also in fair condition. In several areas the retaining walls show evidence of lateral movement. There are trees and bushes growing next to the wall with branches overhanging the channel. A large willow tree growing out of the upstream slope of the dam has fallen across the spillway entrance and can present an obstruction to the flow.

#1 SPILLWAY INLET.

- (c) The spillway paving should be maintained by patching as required. Holes in the spillway should be repaired to prevent erosion and undermining of the channel during heavy flow. The sections of the spillway retaining walls which have moved significantly out of alignment should be relocated or replaced.

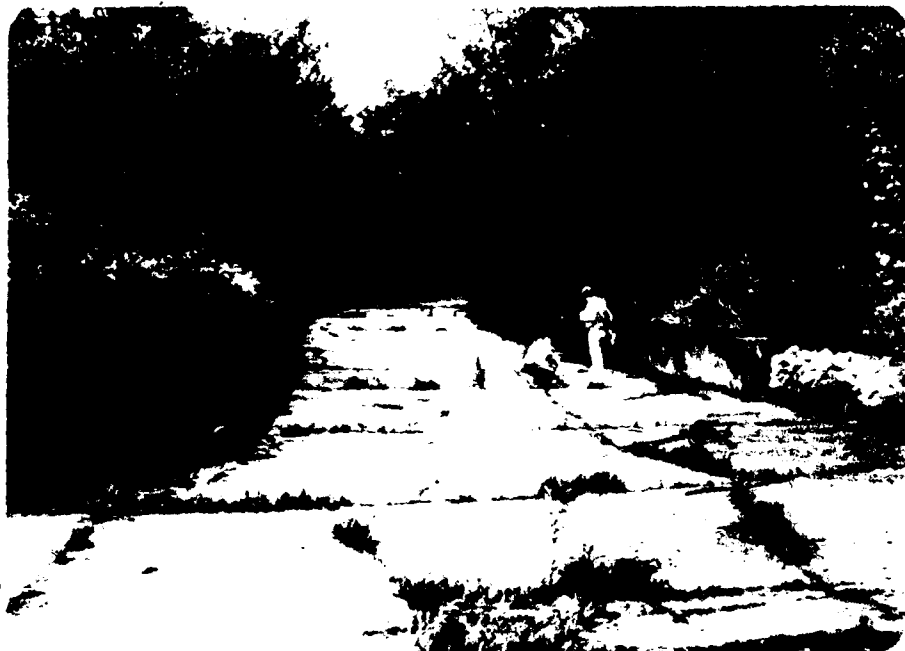
The spillway channel carries water from the spillway crest, over the face of the dam and into a channel leading to the South Reservoir. The spillway channel is paved with concrete, and is in fair condition, especially considering its age. Cracking, weathering and some movement of the concrete paving has taken place, particularly along the construction joints. For the most part the cracks have been repaired with asphalt patch. There was one hole observed in the concrete paving (8-inch diameter) towards the lower section of the spillway.

#2 BOTTOM OF SPILLWAY.

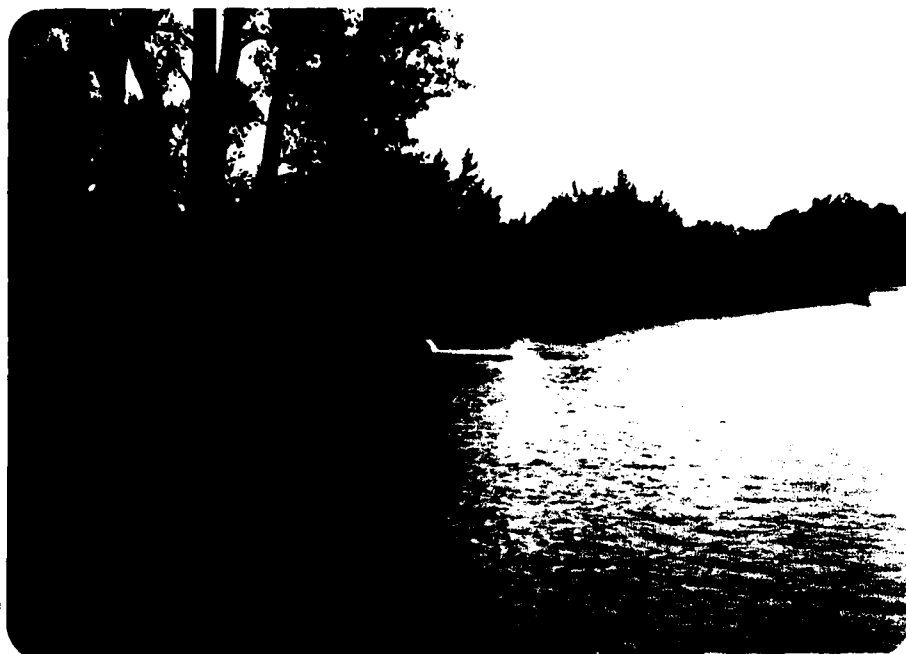
#7 UPSTREAM SLOPE BY LEFT ABUTMENT SHOWING ALSO DISCHARGE  
FROM SOUTH RESERVOIR PUMPING STATION.
